## **Condition Report**

**Artist: Samuel John Lamorna Birch**

**Title: Landscape**

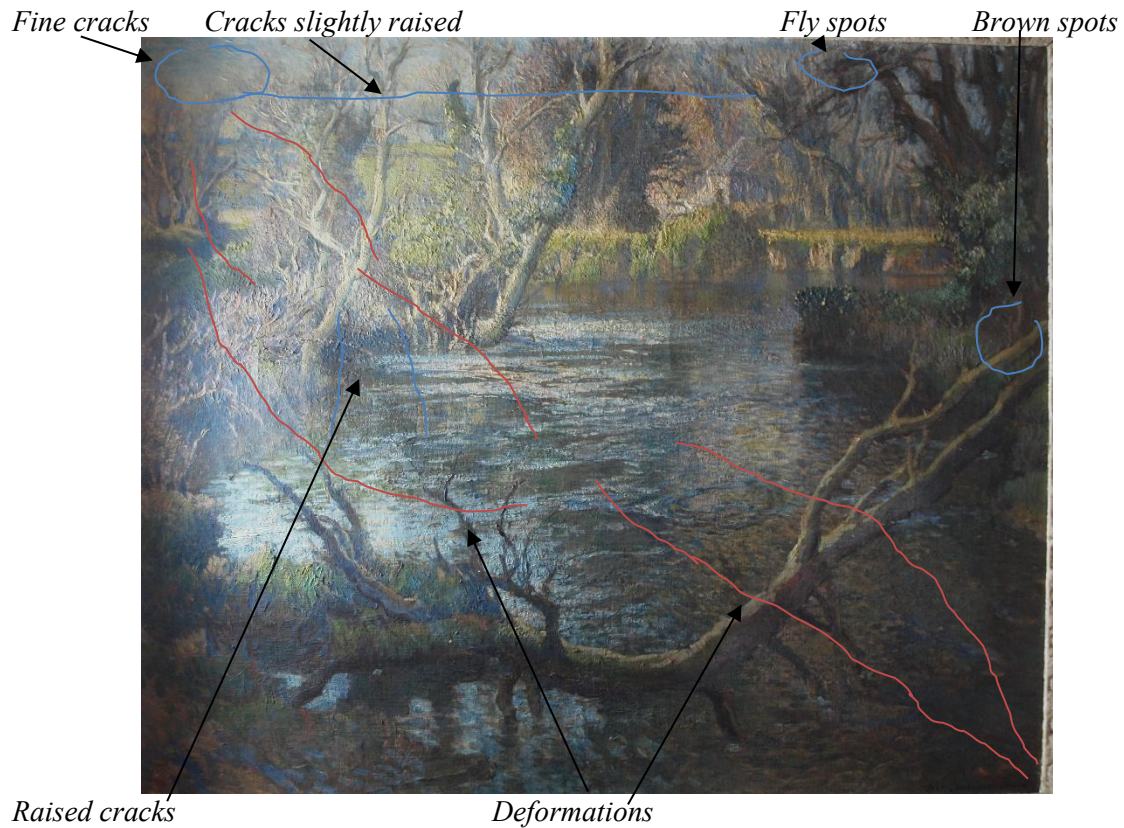
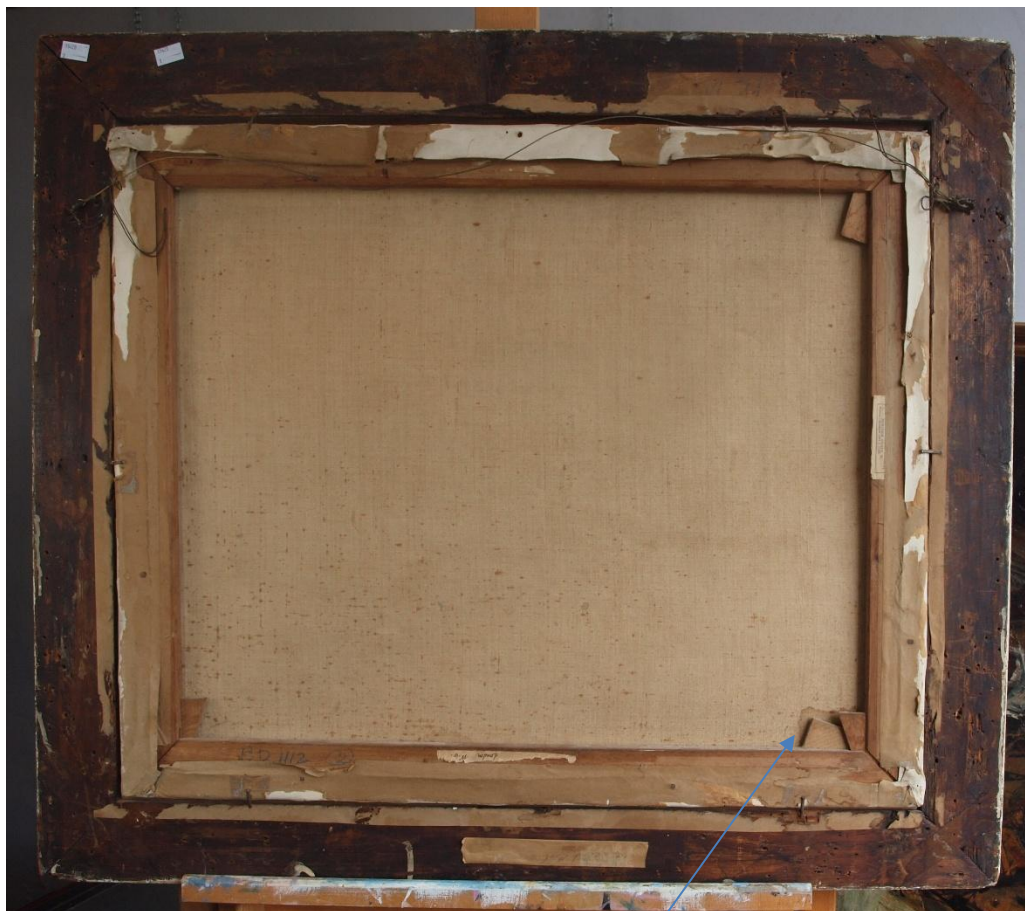
The painting is an unlined oil on canvas with expandable stretcher; 4 stretcher expansion keys are missing. The mitres of the stretcher are open 3-4mm on the right-hand side and the canvas lacks tension overall. The lack of tension has created large deformations across the whole, most significantly from the bottom right corner. There are small spots of brown staining on the reverse of the canvas and a water mark bottom right. There are no holes or tears to the canvas.

*Painting reverse showing brown spotting. Water mark.*

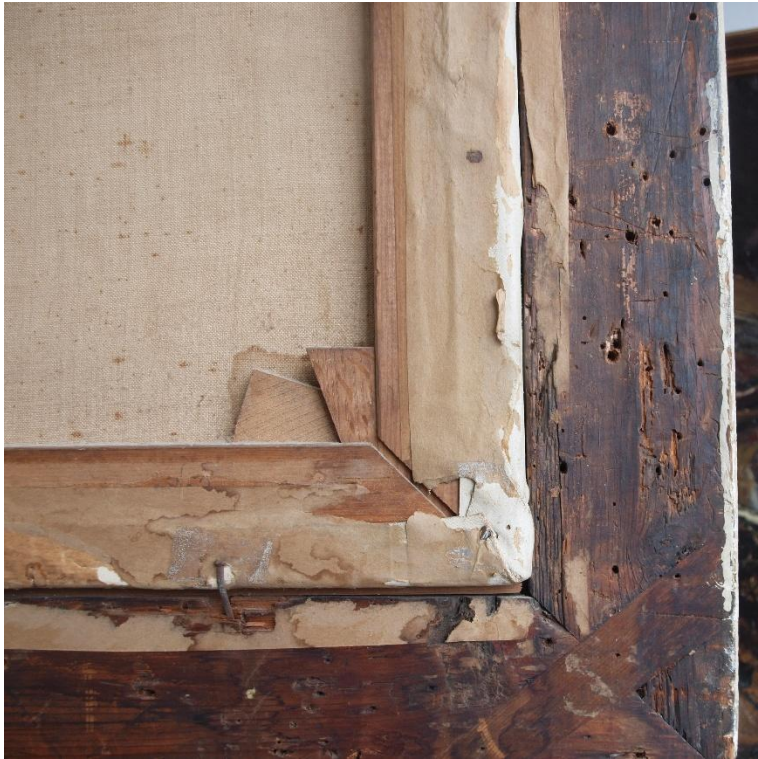
The painting has a carved wooden decorative frame. There is evidence that originally the frame was gilded and has subsequently been gessoed and overpainted in a white glossy paint. The white paint covers some earlier losses and abrasions to the moulding. The top right corner mitre is slightly open but has no movement and there are old losses to the corners and along the bottom edge. There is a fair amount of dust and surface dirt on the frame. Woodworm exit holes can be seen down the lower left-hand side of the frame, this is old damage which does not affect the integrity of the frame and the infestation is not active.

*Detail of woodworm damage to frame.*

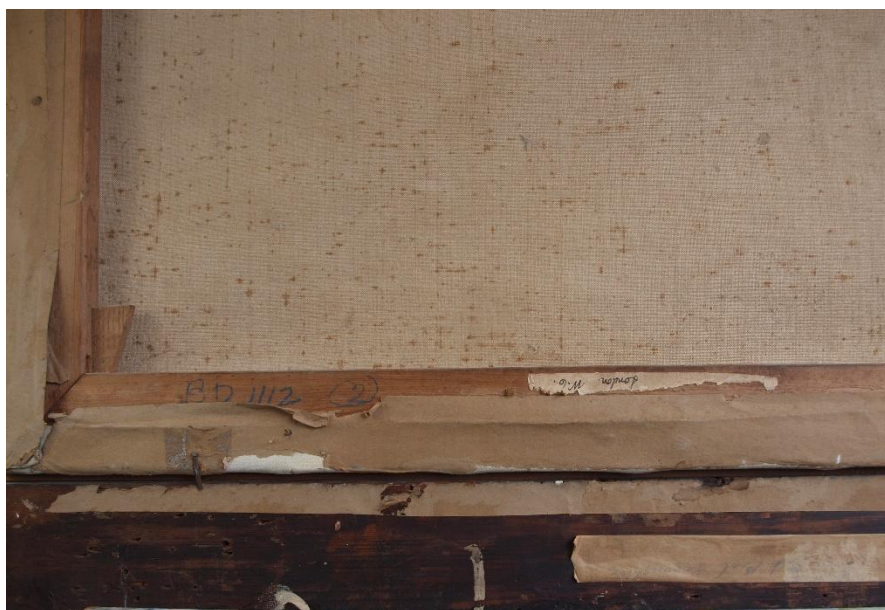
The paint surface overall has a slightly matt appearance due to minimal varnish and surface dirt. Fly spots are evident top right and down the middle of the right-hand side is a small patch of brown spots most likely caused by the painting being housed in damp conditions and related to the brown spotting on the reverse. These spots are limited to this area on the face. Variations in gloss are due to paint application. There is no evidence of previous restoration or treatment for the painting.

*Detail of brown spotting on the reverse.*

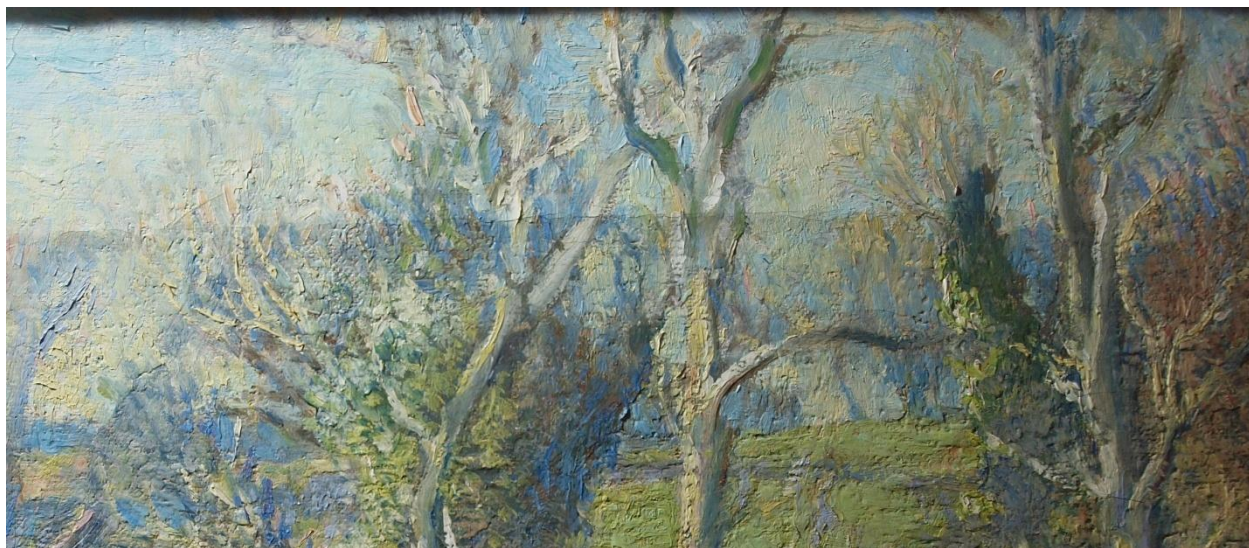
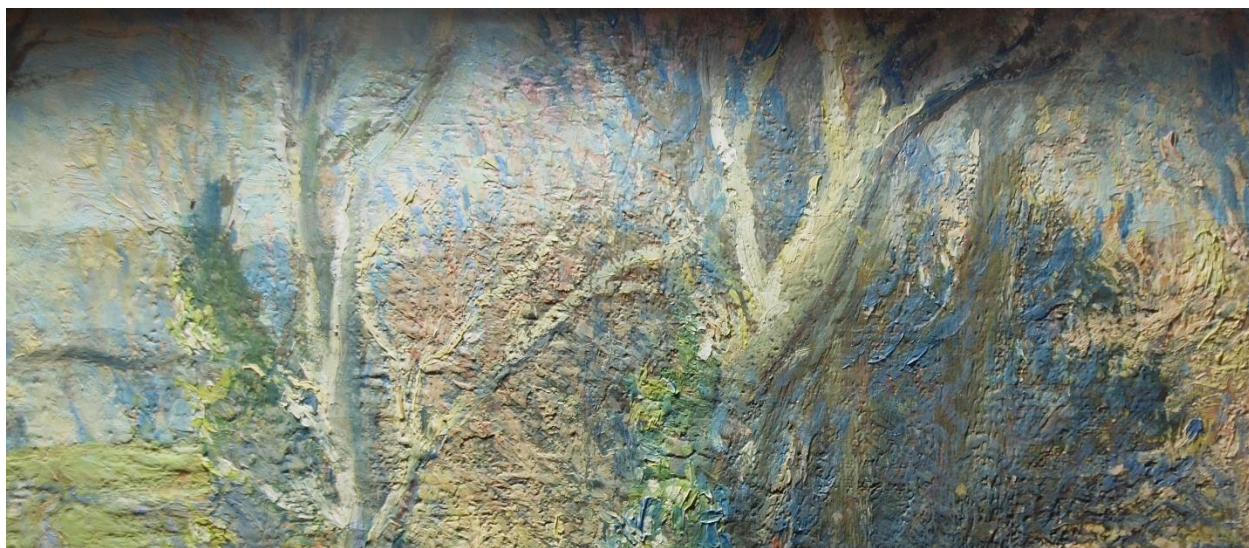
The paint has been directly applied with a degree of impasto onto a white commercial ground. The surface has numerous small cracks and small undulations due to the varying thickness of the paint. The cracks are stable although slightly raised over the line of the stretcher bars and isolated areas as marked above. There are no areas of flaking or paint loss and the impasto is in good condition.

*Details of raised cracks over top stretcher bar.*
