## **Condition Report**

**Artist: Samuel John Lamorna Birch**

**Title: Landscape**

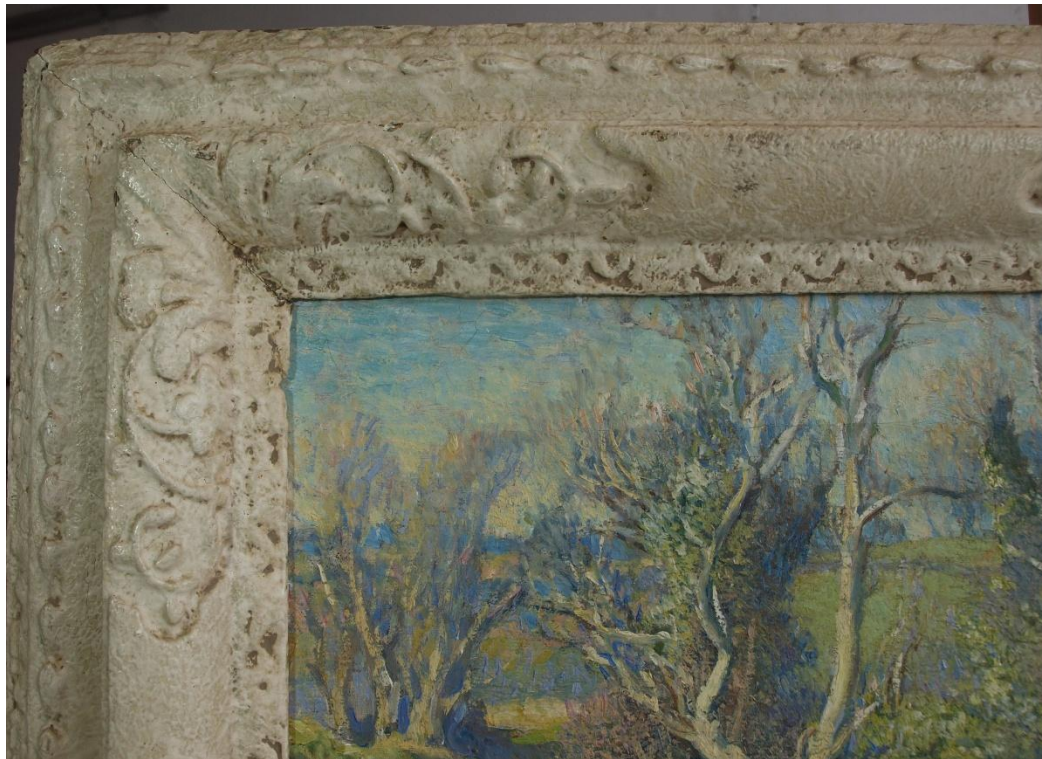
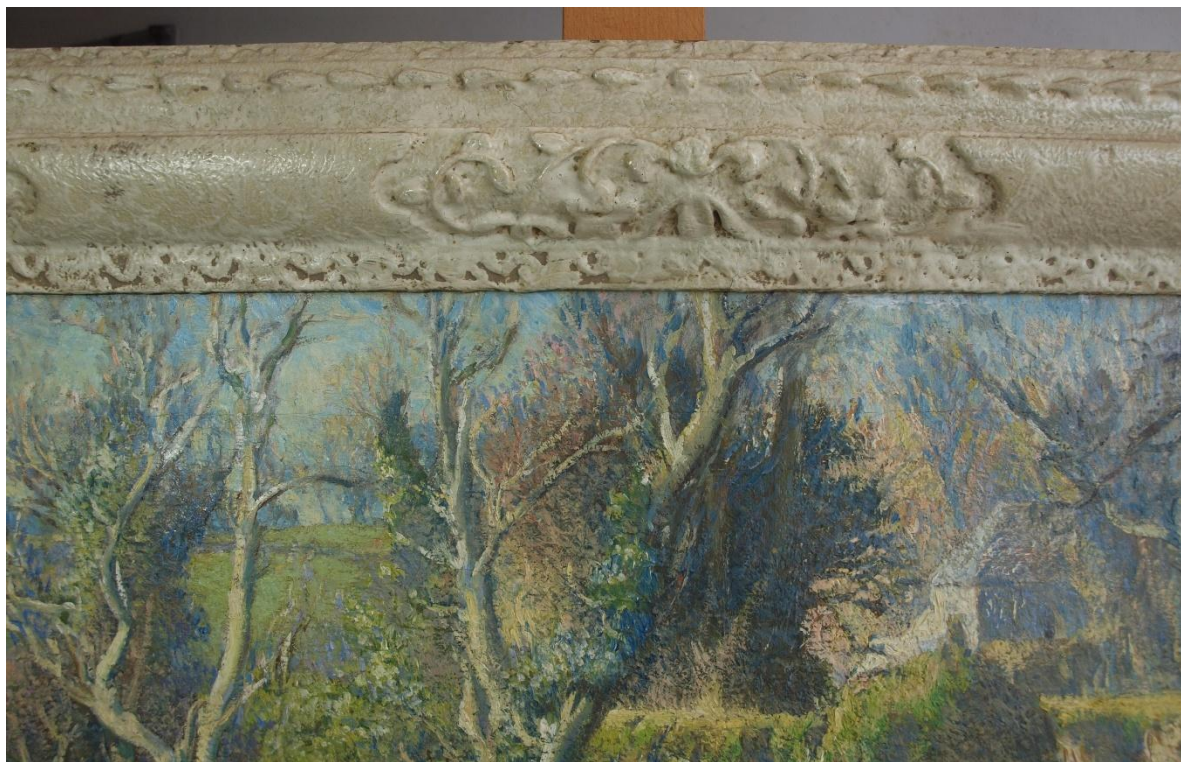
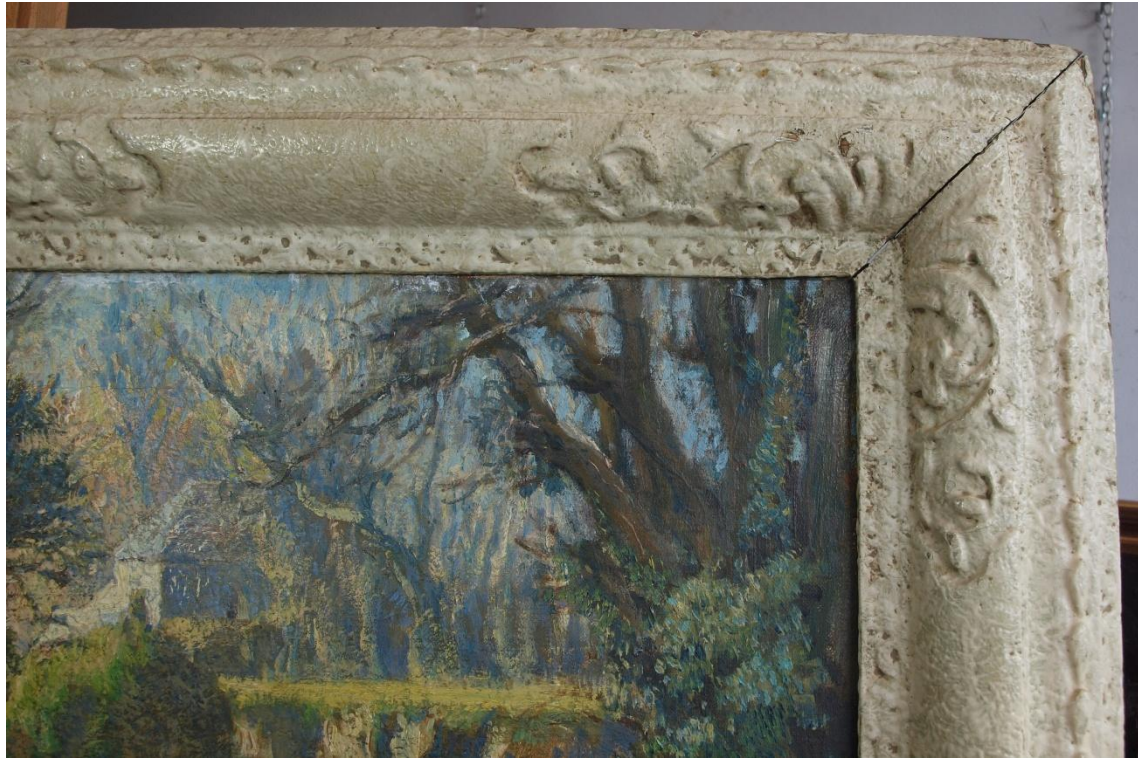
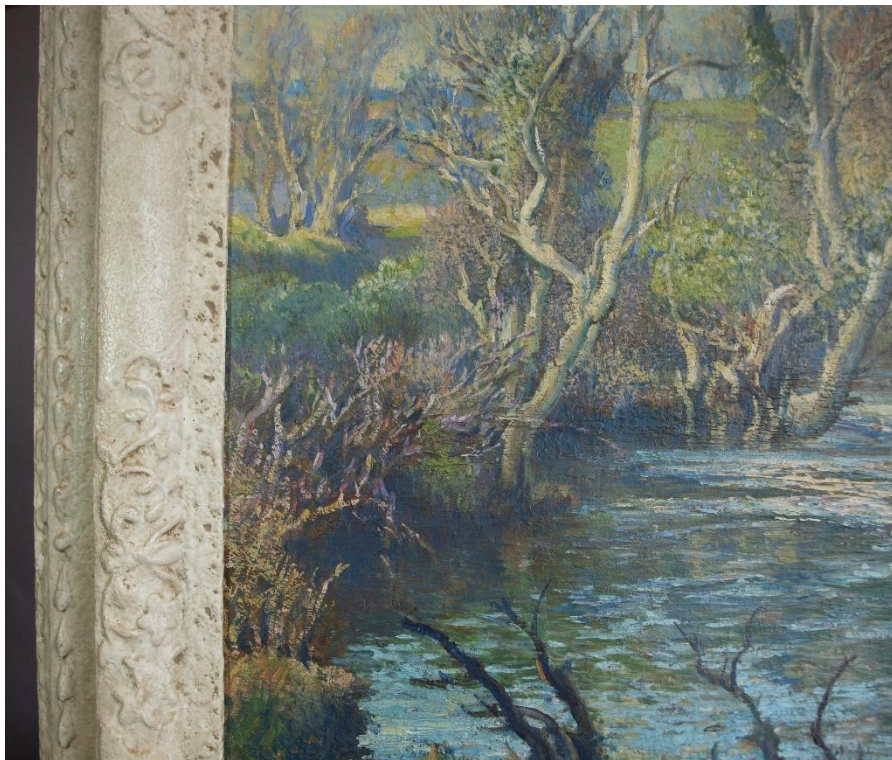
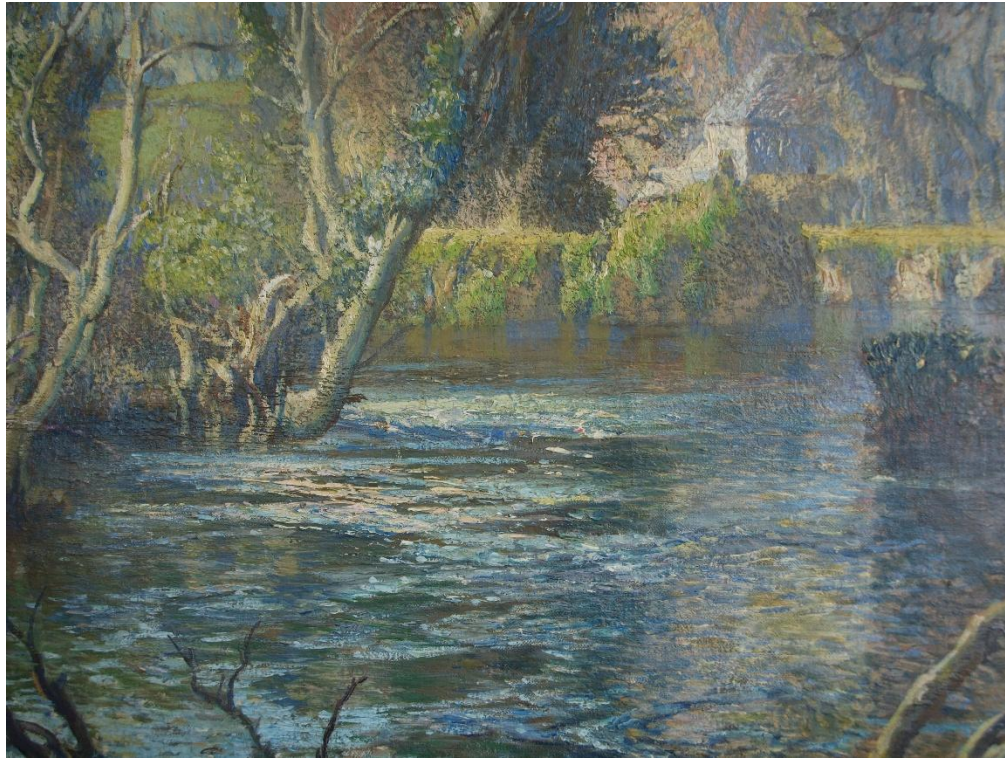
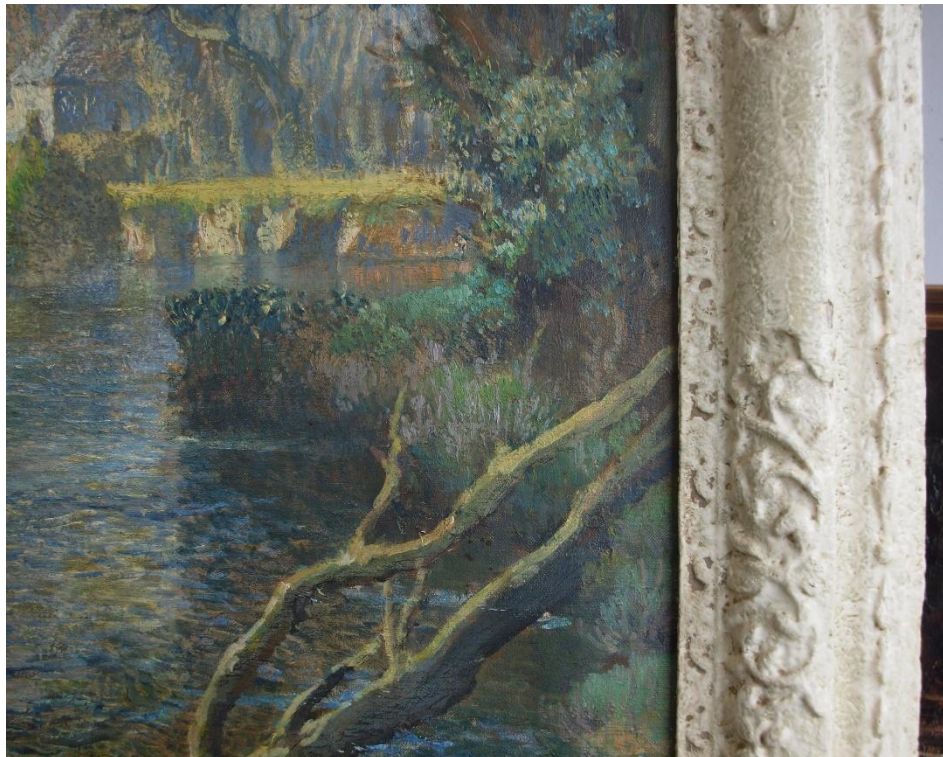
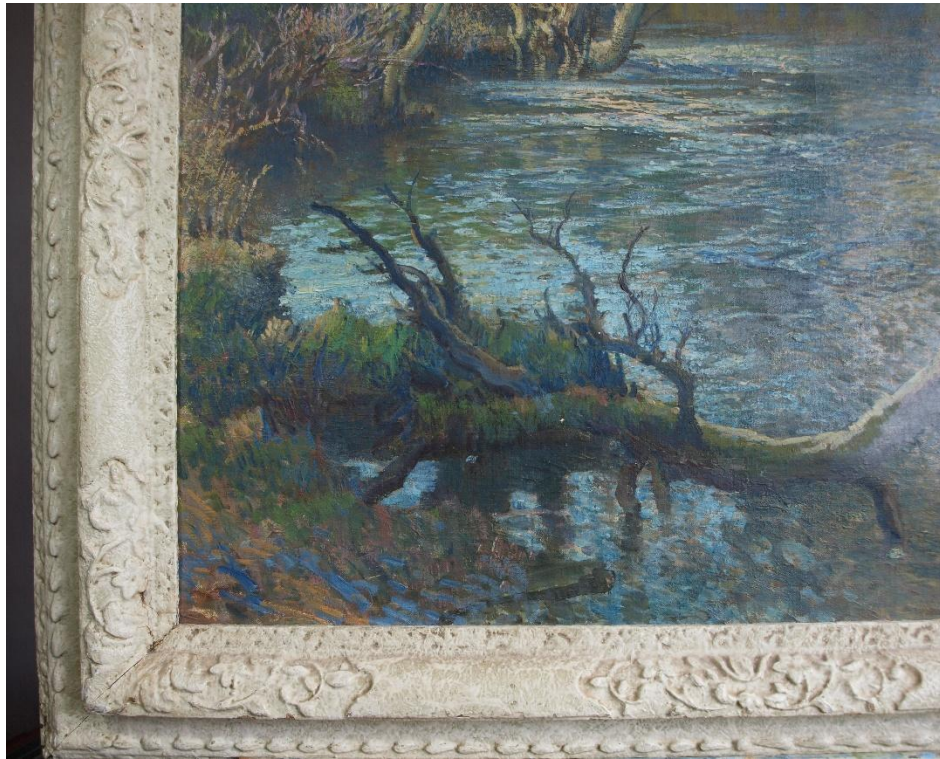
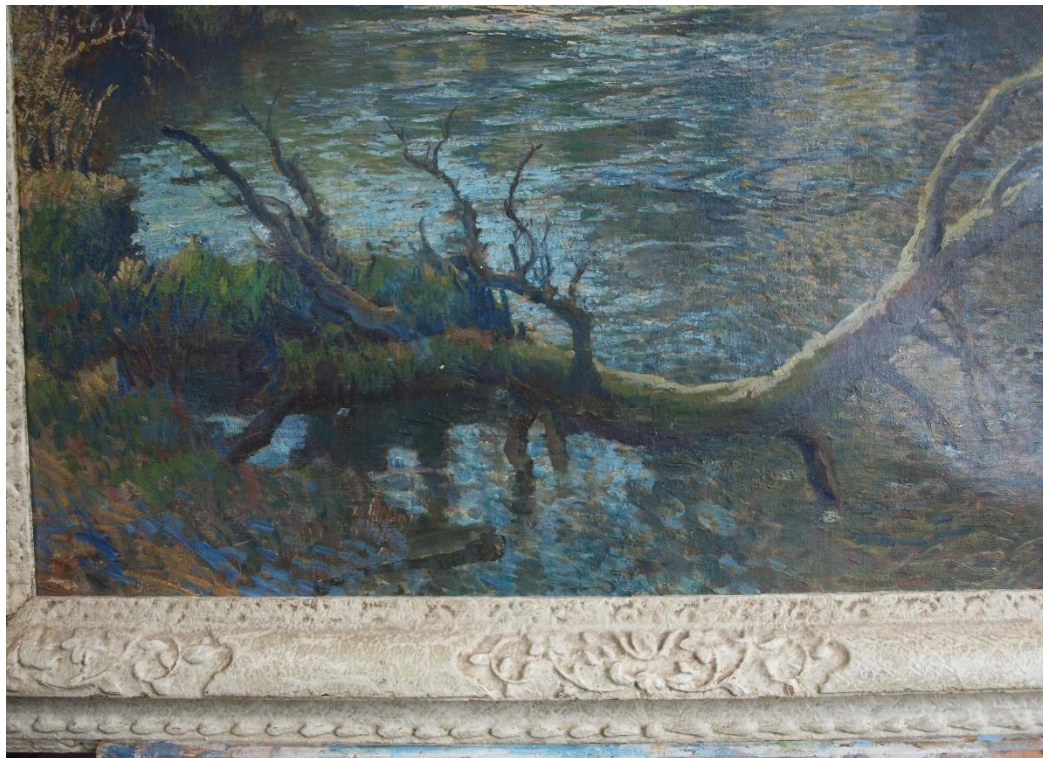
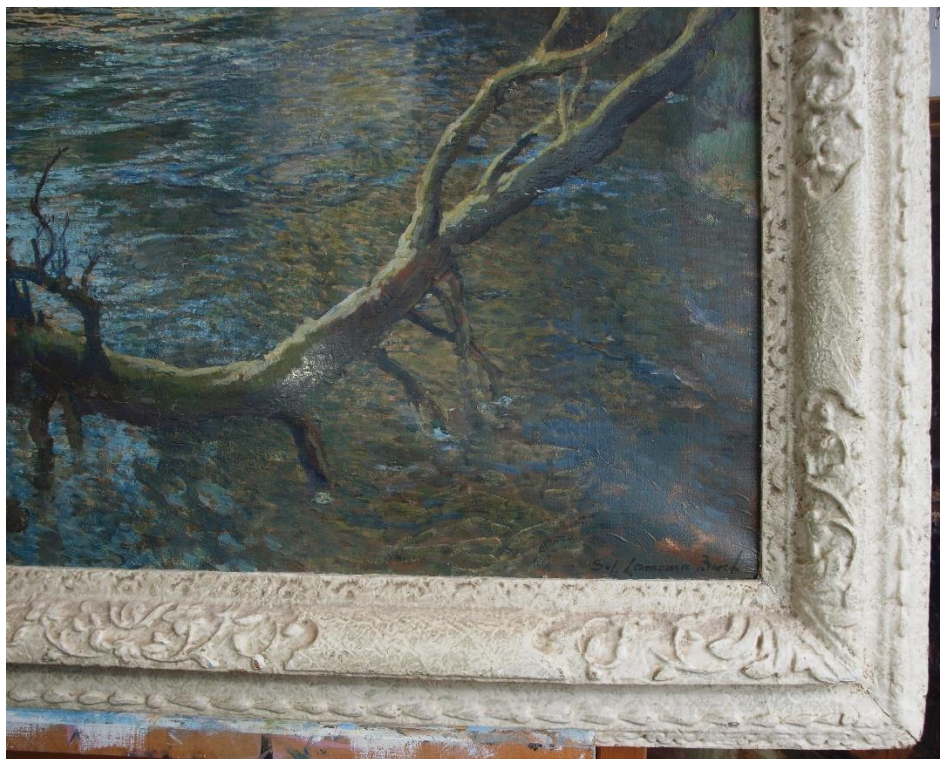
The paint surface overall has a slightly matt appearance due to minimal varnish and surface dirt. Fly spots are evident top right and down the middle of the right-hand side is a small patch of brown spots most likely caused by the painting being housed in damp conditions and related to the brown spotting on the reverse. These spots are limited to this area on the face. Variations in gloss are due to paint application. There is no evidence of previous restoration or treatment for the painting.

The painting has some significant canvas deformations and patches of raised cracks but is stable and in good original condition overall. The deformations and brown spotting on the reverse are due to the painting having been previously kept in a damp environment. Aside from some keying out of the stretcher, the painting appears to have had no treatment or restoration. The frame is likely to be contemporary to the painting and is structurally sound. The gilding has been overpainted at a later stage.

*Detail of brown spotting on the reverse.*

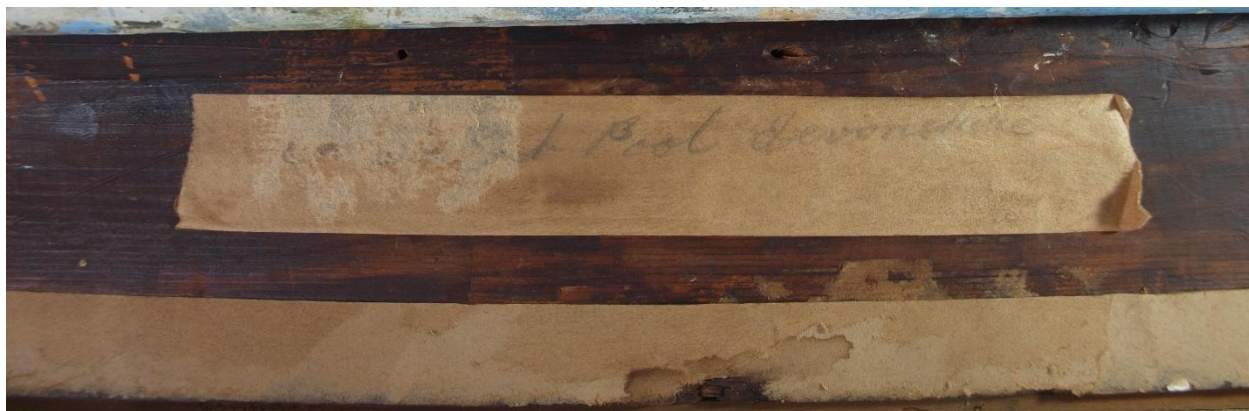
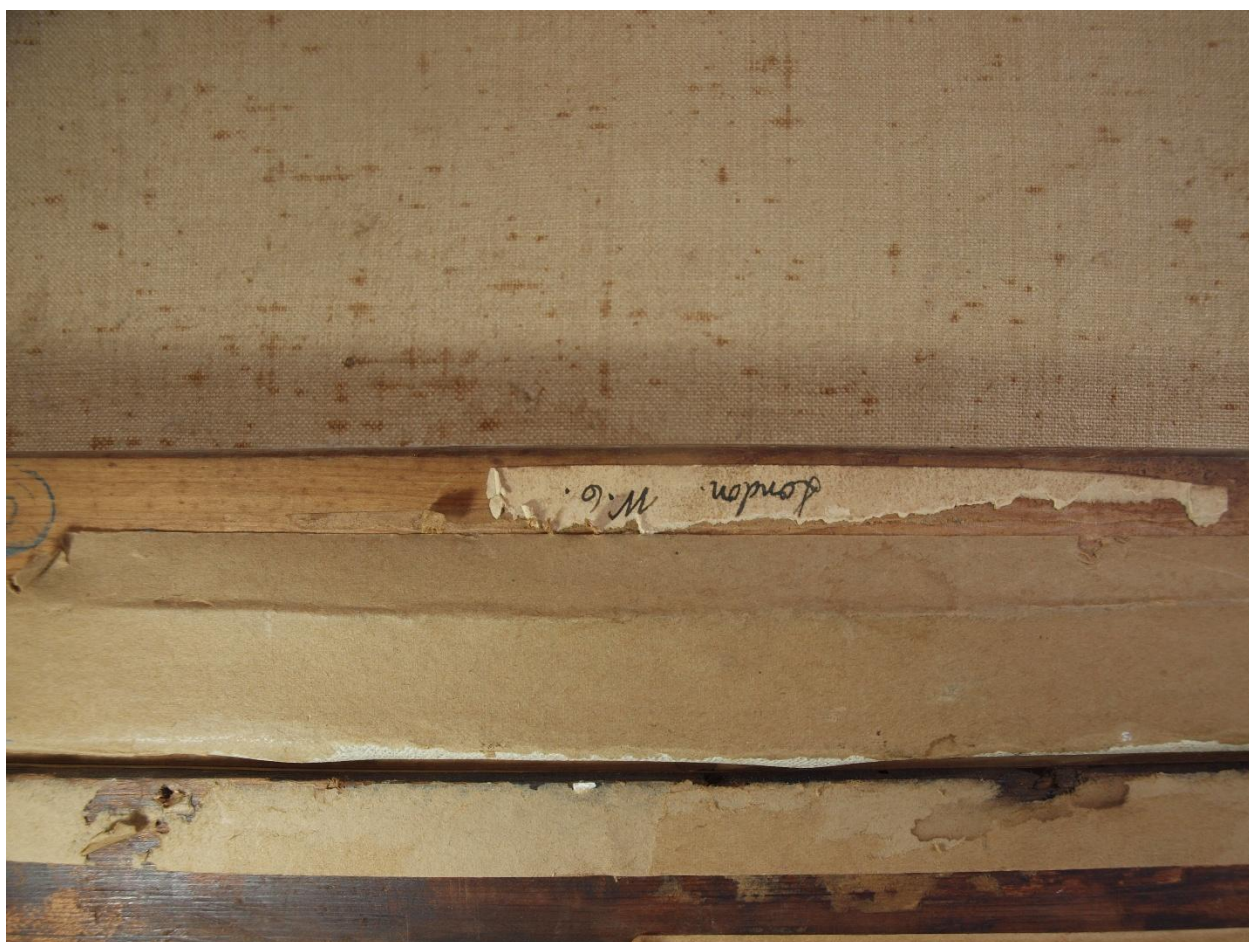
*Details of labels and inscriptions.*
